FY 2014-15

City of Wildomar

MEASURE Z ANNUAL REPORT

Wildomar Parks
Annual Assessment Guide

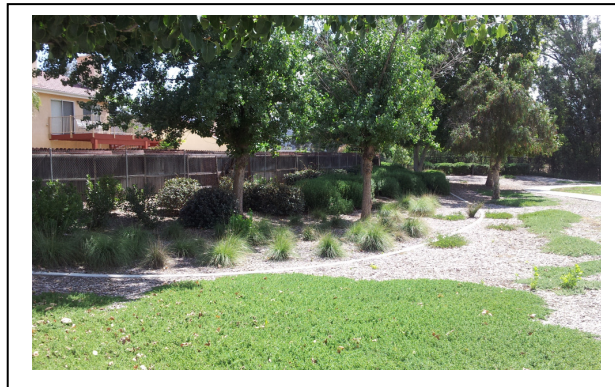
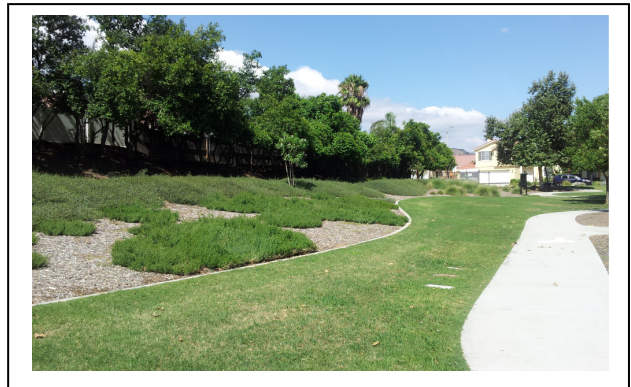
This park is in the best condition of any of the three parks since Wildomar incorporated. Overall, the park is clean and well-kept, free of trash, debris, and graffiti. All shade structures, play equipments, and site furnishings are clean and in good repair.

The turf is in fair condition, but has gopher holes and needs some weed eradication. Most of the trees in the park are pruned properly and in a healthy condition. However, the several trees need to be re-staked. Many of the new shrubs and ground covers have grown over the past year, but several have been lost. The areas where plants have died still need to be replanted. About a 90% of the planting area is moving toward plant establishment.

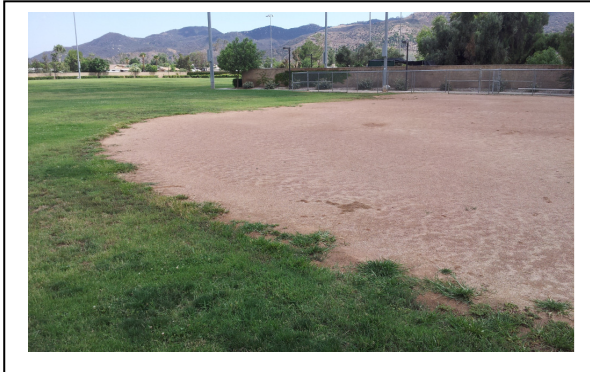
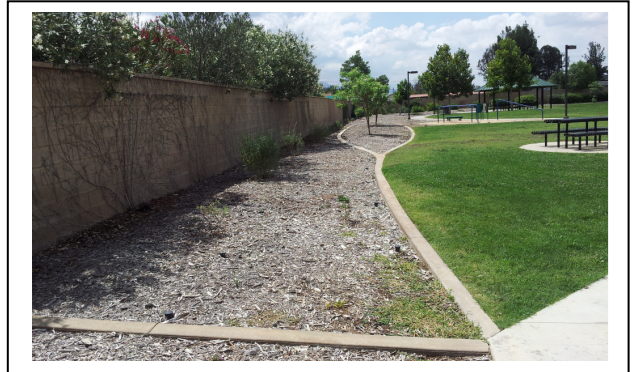
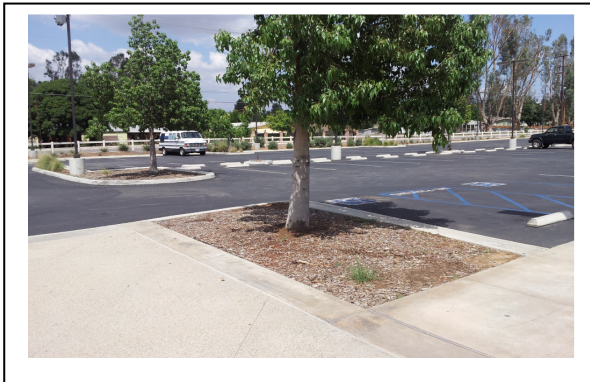
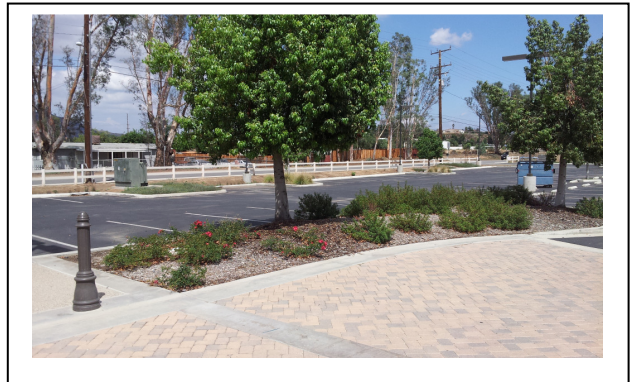
Marna O'Brien Park

The facilities at this park are in good condition. The parks is free of trash, debris, and graffiti. All shade structures, play equipments, and site furnishings are clean and in good repair. The only facility item needing attention is paint for fascia on the snackbar/restroom building.

The turf requires significant weed eradication and repair in heavy wear areas. The ballfields have gopher holes and minor drainage issues. The infield arc for the ballfields requires edging and there are weeds in the infield brickdust and dugouts. Most of the trees in the park are pruned properly and in a healthy condition. Several require re-staking. This park still needs additional planting due to the loss of shrubs and groundcover. Some have survived, but in all, more plant material has been lost since last year without replacement. The Crape Myrtles along the street are not doing well. Many shrubs have not survived in perimeter planters, parking lot islands, and the street frontage swale. There should be a replanting program as I had mentioned last year. About 85% of the planting area is either established of

moving toward plant establishment. It is possible for this park to be brought into Average condition with reasonable effort.

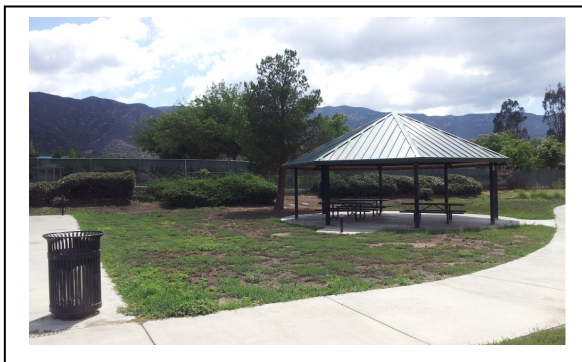
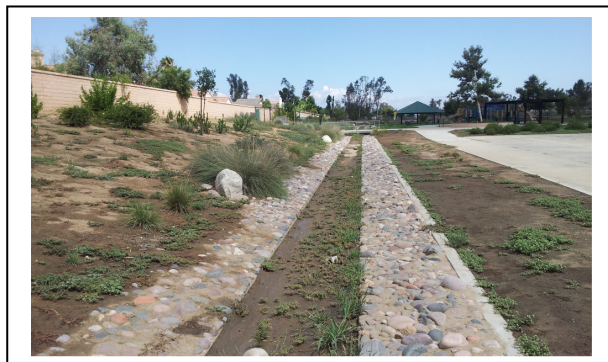
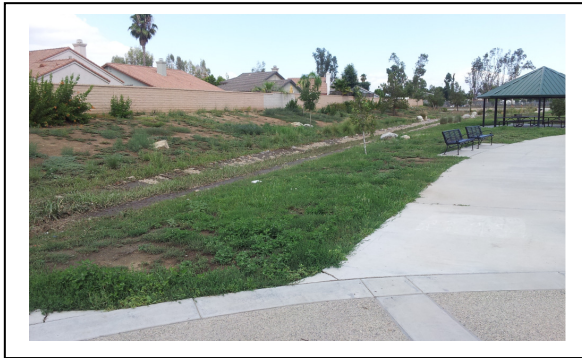
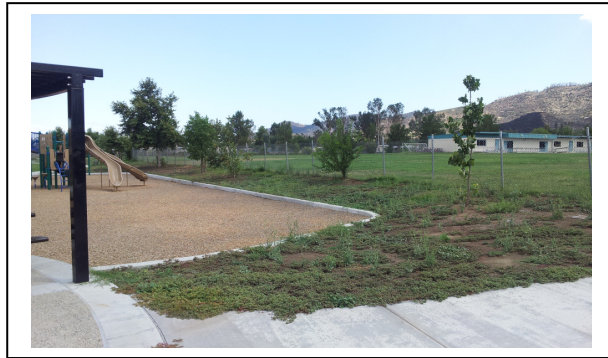
Heritage Regency Park

Overall, this park is in very poor condition because of the lack of landscape care. The condition is a disappointment and embarrassment to our city. The facilities for this park are acceptable, but there is some trash and debris present, especially in the drainage swale. All shade structures, play equipments, and site furnishings are clean and in good repair.

There are still large areas with no turf. New trees in the park need to be re-staked. There are several areas where the plants have not established and still have not been replaced or installed. The vacant planting areas and missing turf are now fields of weeds. The southern half of the drainage swale has mud and weeds in it. Less than 50% of the planting area is moving toward plant establishment. It would require significant time and effort to bring this park into Average condition.
